1. NAME	
COMMON:	Emerson Pickett House
AND/OR HISTORIC:

Emerson Pickett Log House, site  
Frederick Road (MD 144), Lisbon  
continued

<b>1. NAME</b>	
COMMON: Emerson Pickett Log House	
AND/OR HISTORIC:

MARYLAND HISTORICAL TRUST - HISTORIC SITES SURVEY

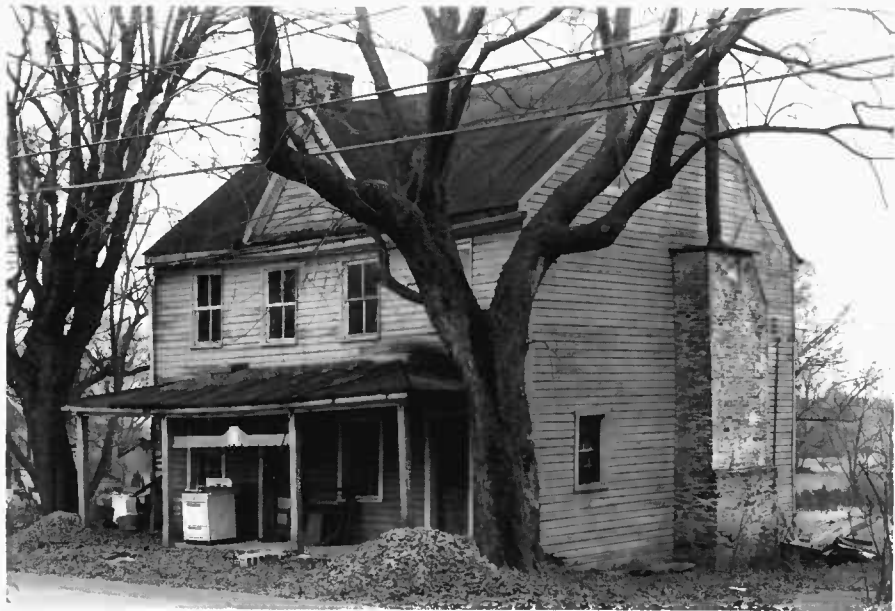
HO 203

Exceptionally large for a log house, this building, almost square, covered with clapboard, has lost a large section of its foundations at the rear and is in imminent danger of collapse. The house faces north onto Frederick Road. Four bays by two, 2 1/2 stories high, a large cross-gable style peaked dormer with sawtooth decoration at the cornices has been added to the north slope of the roof. Exterior chimneys raise to the peak at each end of the house from heating fireplaces. The first floor front elevation contains two doors and two sets of 6/6 sash windows. At the second floor level are four windows containing sash of 2/2 panes. The full-length shed-roofed porch has square posts with Victorian brackets at the eaves.

Numerous alterations include removal of partitions to the interior, erosion of the cellar walls, exterior and interior, and changes in some windows from 6/6 to 2/2 lights, as well as a partly removed chimney with a tin flue replacing the top 12'-20' of the stack.

Pickett's log house Lis ben 18E 11/72

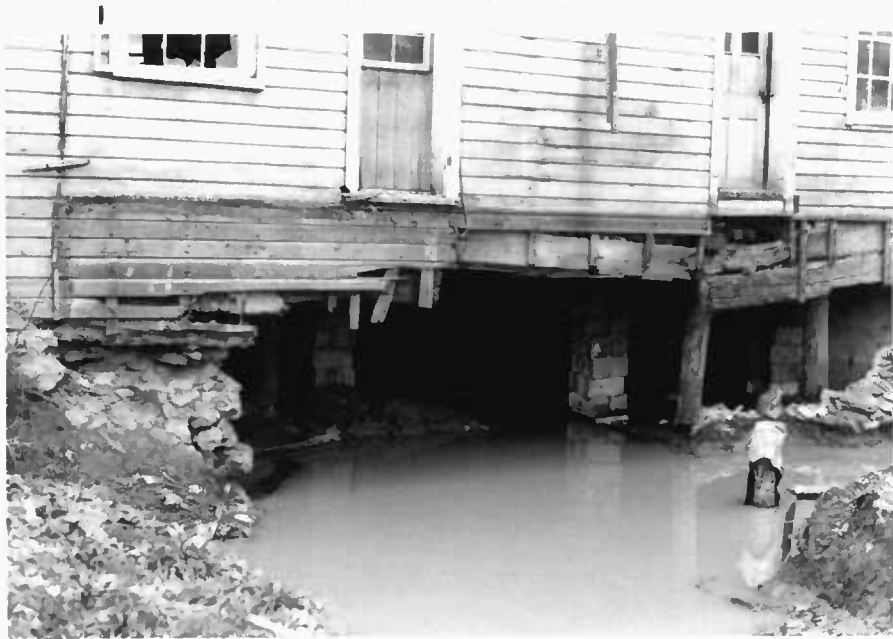
H0203

Pickett's log house Lisbon JSS 11/72
